Fire Risk Assessment

3 Queensland Road

Version 9

21 July 2020

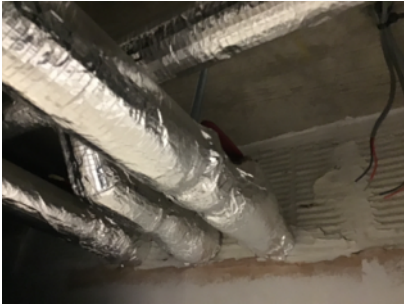
Example of good fire stopping, above ceiling, above entrance to flat 25

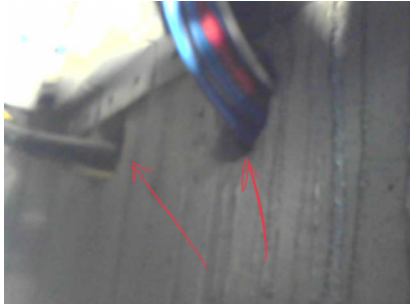
Penetrations into lift shaft without fire stopping, 10th floor.

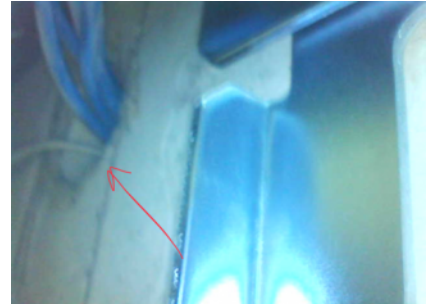
Penetrations into lift shaft without fire stopping, 10th floor.

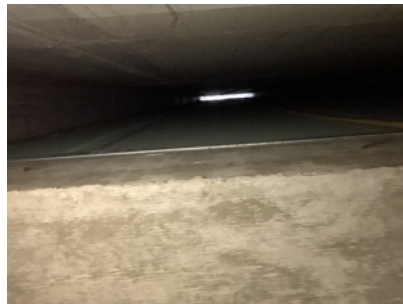
Void at rear of pump room, lower ground floor to roof.

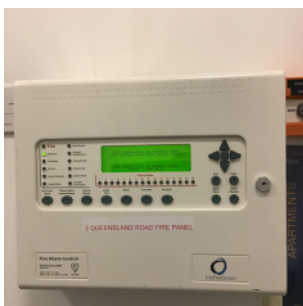
Control panel

There are no faults or alarms standing

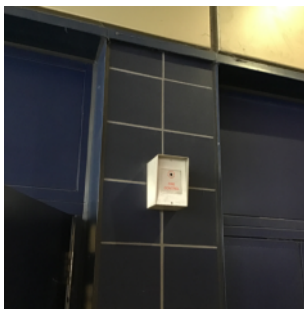
The entrance door overrides were tested at the time of inspection and all were found to operate correctly

Rear exit door override.

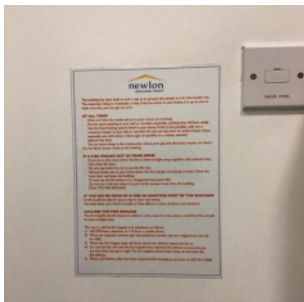
Fire Action notices are not displayed in main front entrance.

Fire action notice at side entrance

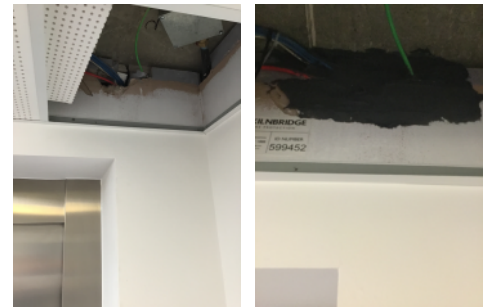
10th floor, above ceiling into lift shaft above BOTH lifts.

Inspection utilising a borescope confirmed these penetrations are through the concrete lift shaft and are not fire stopped.

Source Version 1
Ref 117433
Category Escape Routes & Fire Spread
Sub Category Construction and Glazing
Action Required Provide fire stopping around cable penetrations in the following locations:

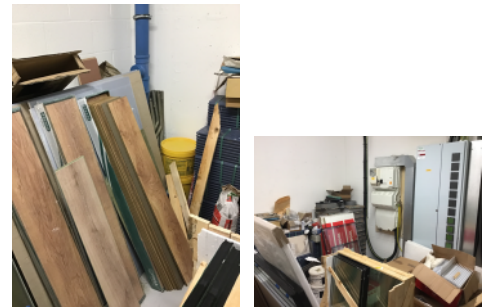
Within the electrical intake room, (landlords meter room), ground floor.

This has an extremely high build up of combustible items, which in the main appears to be contractors supplies and building materials, including wooden flooring, floor coverings, paints and floor adhesives.

Version 7 29/1/20 The combustible material originally noted has not been removed, task returned to identified.

Source Version	1
Ref	117442
Category	Fire Prevention
Sub Category	Housekeeping
Action Required	The storage of combustibles in the following locations was excessive and should be significantly reduced:

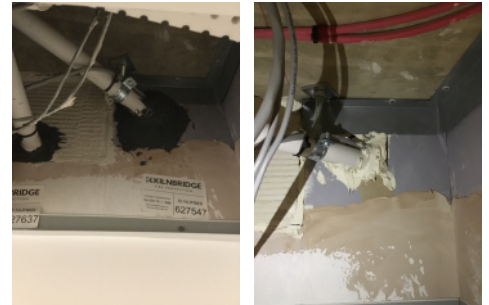
Above ceiling, above entrance to flat 10.

The PVCu pipe, with mastic sealant creates an opening greater than 100mm and therefore should have some supported fire stopping applied.

Source Version	1
Ref	117438
Category	Escape Routes & Fire Spread
Sub Category	Construction and Glazing
Action Required	Provide fire stopping around pipe penetrations in the following locations:

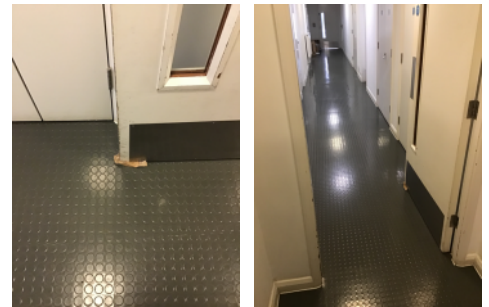
Ground floor corridor.

Version 7 29/1/20, no wedges in use at time of this assessment.

Source Version 1
Ref 117432
Category Escape Routes & Fire Spread
Sub Category Fire Doors
Action Required Wedges should not be used to hold open fire doors.
