**Fire Risk Assessment**

**1 Queensland Road**

Version 9

01-04-2020

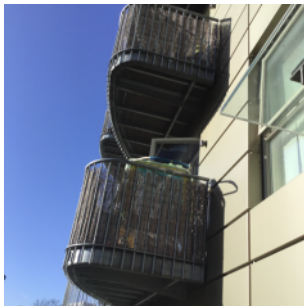
Whilst beyond the scope of the Fire Safety Order, as a private balcony is not part of the common area, residents should be advised about the risks arising from the presence of combustible materials on balconies. They should make clear that smoking, the use of barbecues and storage of flammable property on balconies can increase that risk. Advice from fire and rescue authorities is also clear that barbecues should not be used on balconies.

Balconies.

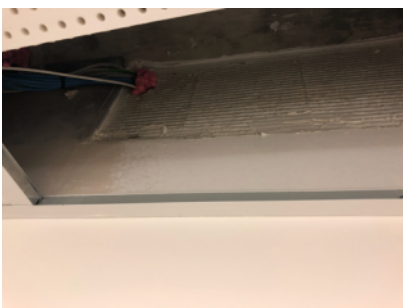
Poor fire stopping

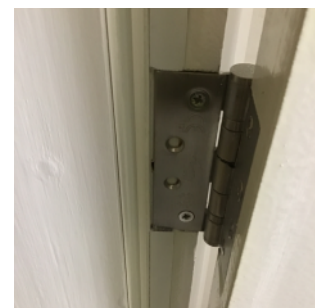
Missing screws on ground floor staircase door

Source Version	9
Ref	340651
Category	Escape Routes & Fire Spread
Sub Category	Fire Doors
Action Required	Screws missing from door to staircase on ground floor.
Priority	Low
Status	Completed
Owner	Wates FRA
Due Date	01-04-2021

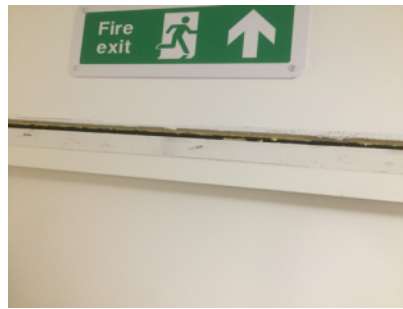
4th floor staircase door frame before fire stopping.

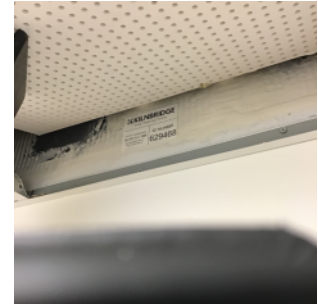
Version 8 Fire stopping 5th floor electrical riser

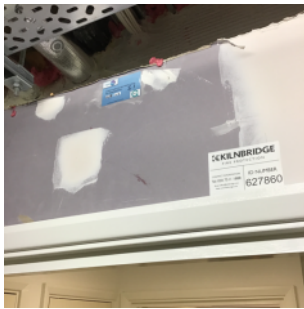
Version 8 Evidence of fire stopping in 5th floor electrical riser

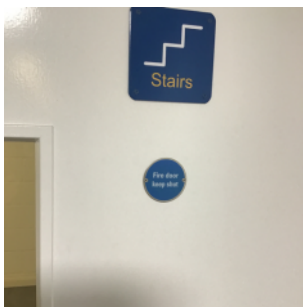
Example fire door signage

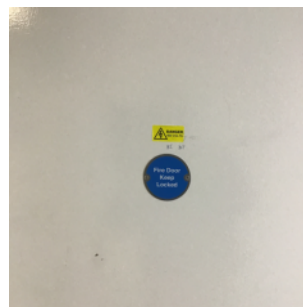
Example fire door signage.

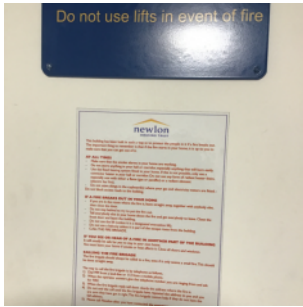
Fire action notices are displayed that correctly reflect the stay put strategy in place for this building

Fire action notice ( rear entrance)

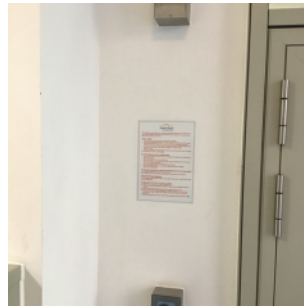
Fire action notice ( front entrance)

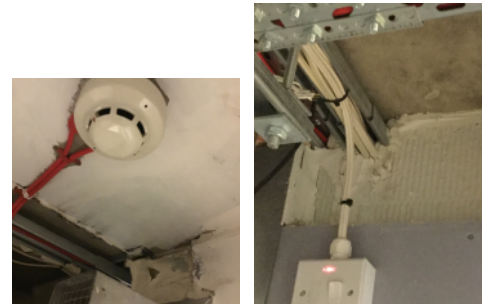
## Task 1

Source Version	1
Ref	118101
Category	Escape Routes & Fire Spread
Sub Category	Construction and Glazing
Action Required	Provide fire stopping around cable penetrations in the following locations: In the riser cupboard at the end of the corridor by flat 59. 7th floor.
	Version 8 29/1/20 fire stopping not completed , further photographic evidence included, task returned to identified. See 6th floor riser cupboard for example of fire stopping required.
Priority	High
Status	Completed
Owner	Property Special Projects
Due Date	18-09-2018

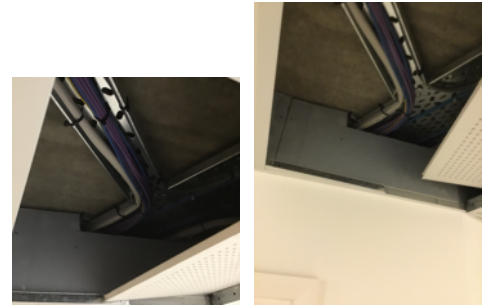
## Task 9

Source Version	1
Ref	118117
Category	Escape Routes & Fire Spread
Sub Category	Construction and Glazing
Action Required	Provide fire stopping around cable penetrations in the following locations: Above the door to the electrical riser ground floor cupboard.
	Version 8 29/1/20, fire stopping not completed, further photographic evidence included and task returned to identified.
Priority	Medium
Status	In Progress
Owner	Property Special Projects
Due Date	12-11-2018
