Fire Risk Assessment

3 Queensland Road

Version 9

21 July 2020

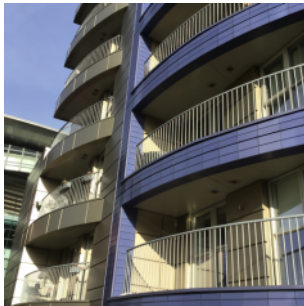
Balconies

Whilst beyond the scope of the Fire Safety Order, as a private balcony is not part of the common area, residents should be advised about the risks arising from the presence of combustible materials on balconies. They should make clear that smoking, the use of barbecues and storage of flammable property on balconies can increase that risk. Advice from fire and rescue authorities is also clear that barbecues should not be used on balconies.

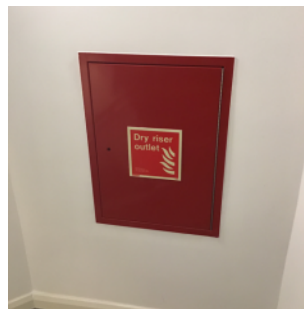
Example dry riser outlet.
